ADDENDUM NO.: 01
PROJECT NAME: Property Management Services at the Richard J. Daley Center
CONTRACT NO.: PS3086
DATE OF ISSUE: September 7, 2023

2015 Asbestos-Containing Building Material Re-Inspection Report

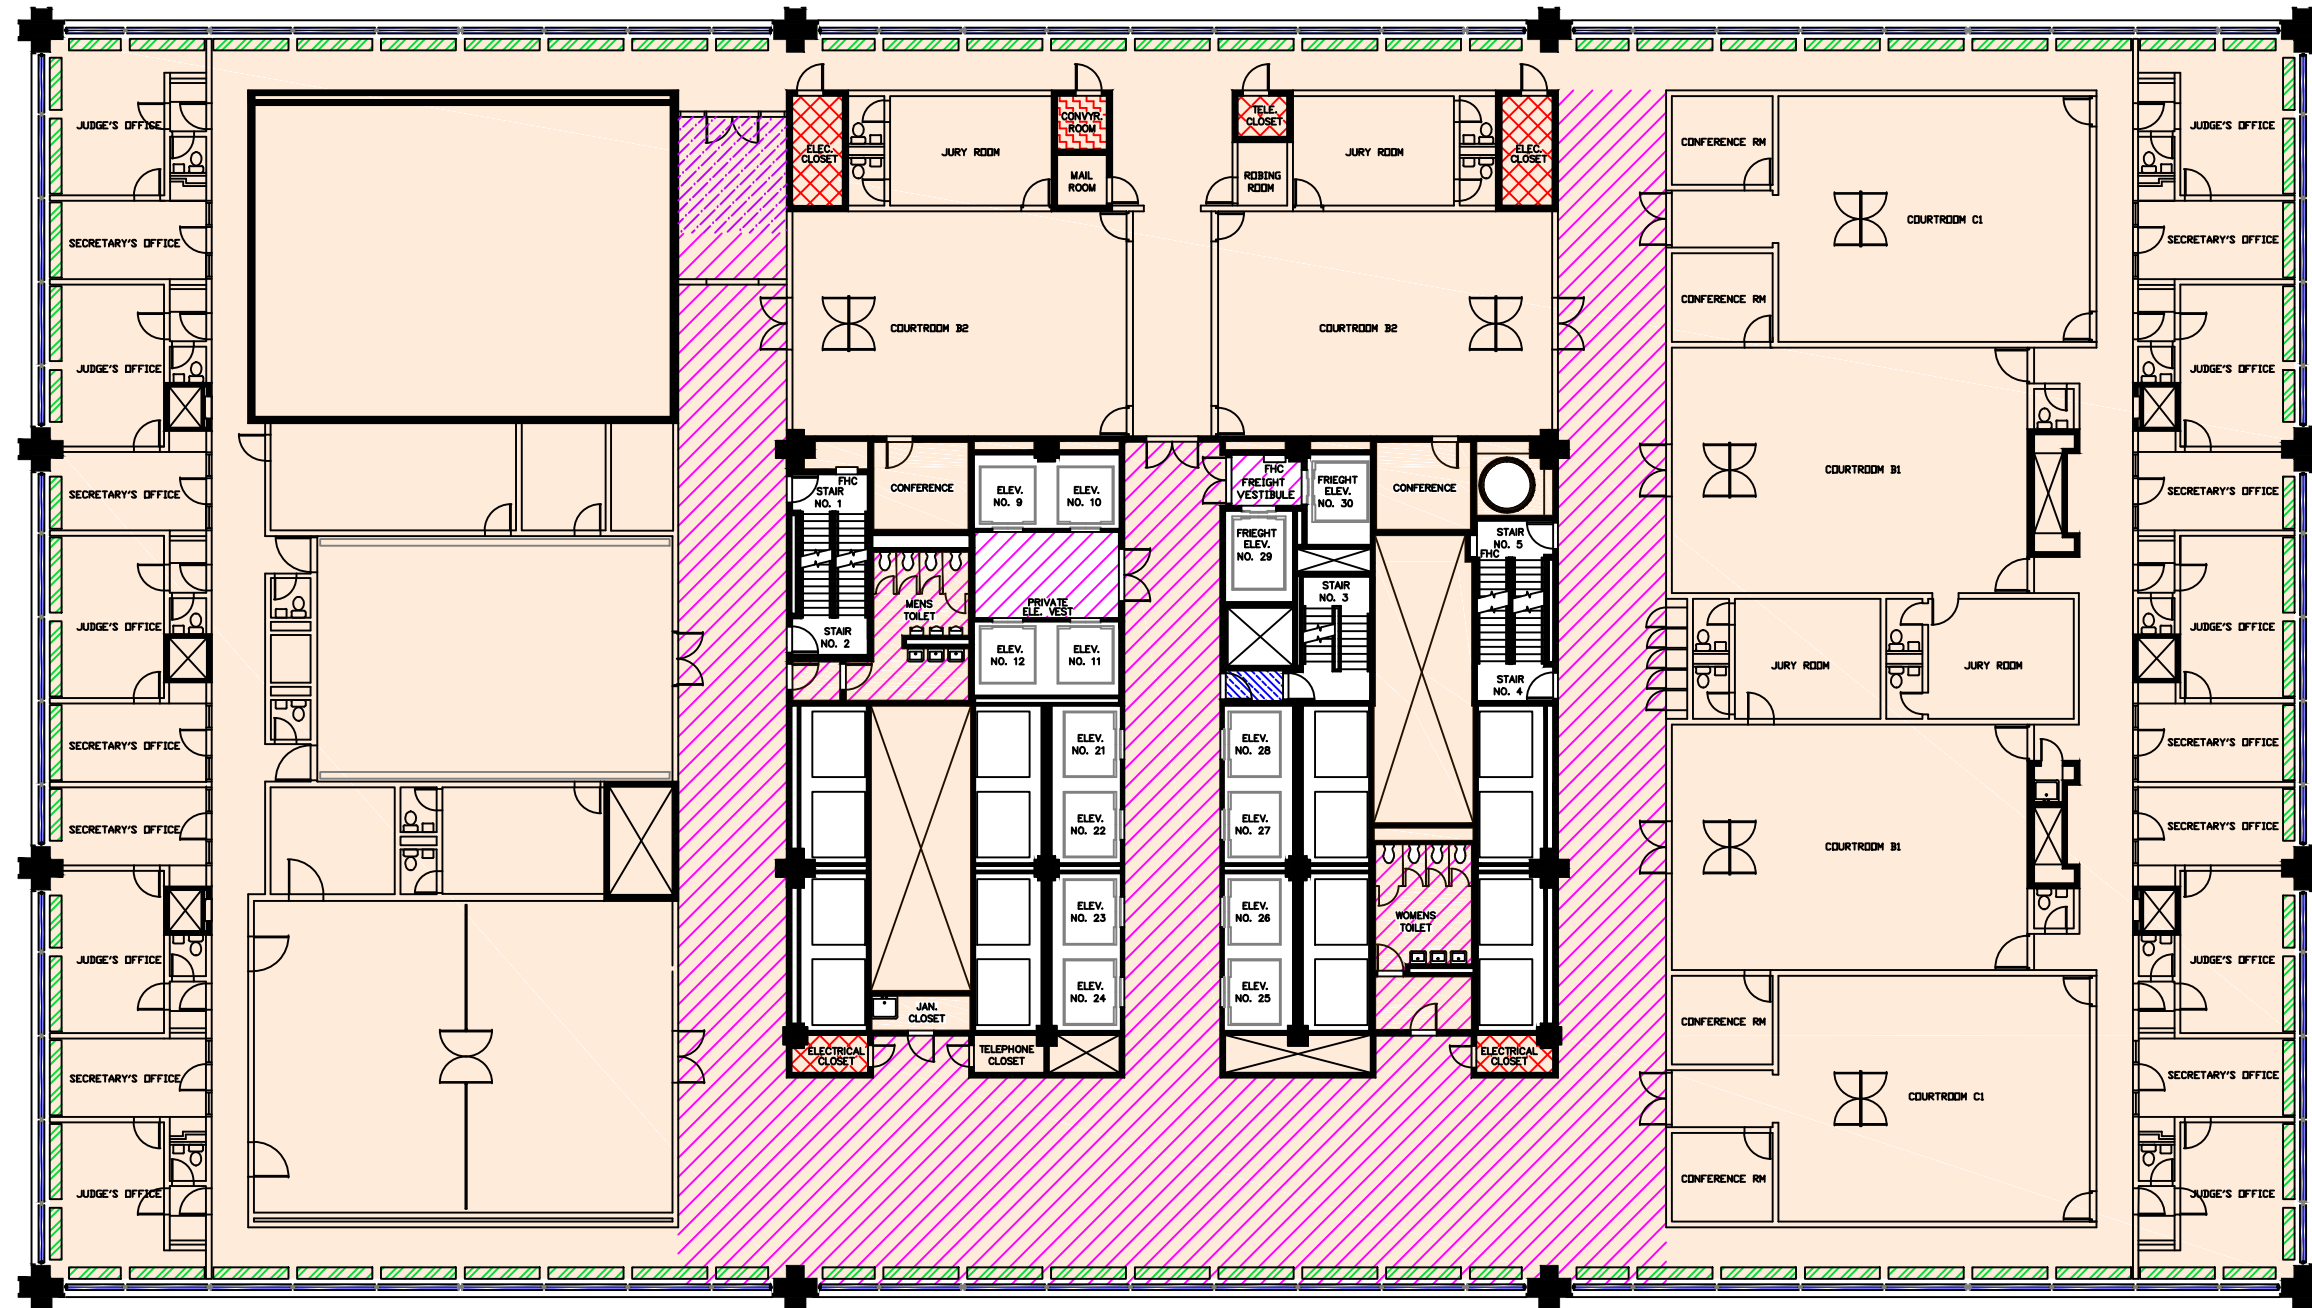
*Asbestos containing spray applied fire proofing and thermal insulation are present above existing ceiling (Exact locations not shown on drawing)

*Locations of materials updated for this 2015 Reinspection

*Entry into interstitial space above existing ceiling requires 16 hour asbestos training, personal protective equipment and compliance with Building's asbestos operation and maintenance plan
